# Defect tolerant lifing of airframe components and the influence of corrosion damage.

# **Defect Tolerant Lifing of Airframe Components and the Influence of Corrosion Damage**

***Christopher Morgans  
Ph.D Thesis 2007***

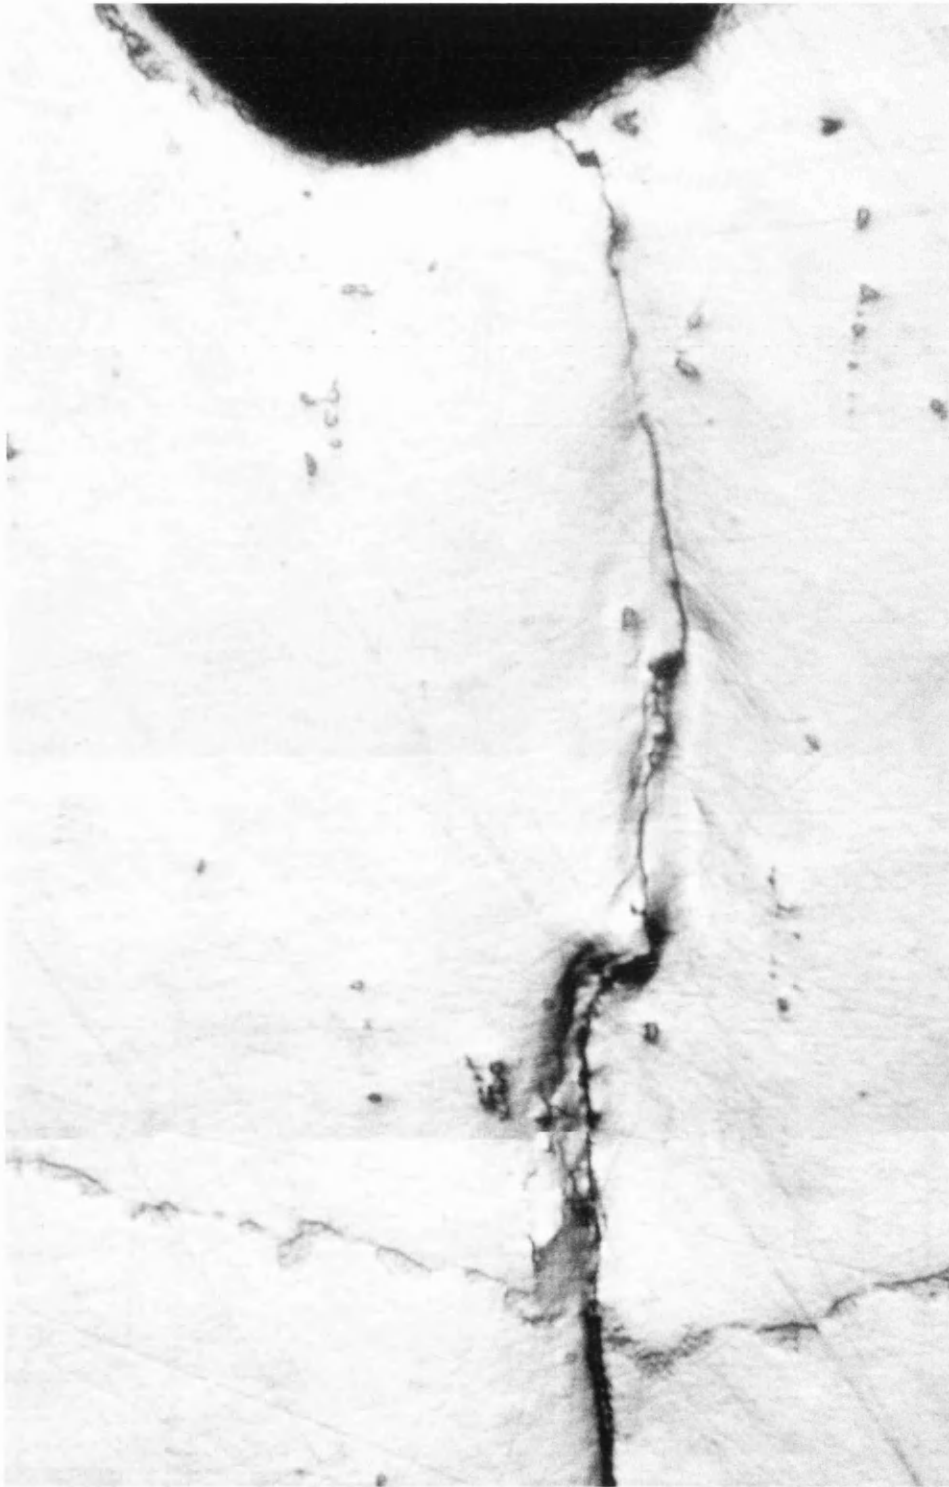
**Figure 5.34** Surface fatigue crack in a SEN specimen illustrating crack path deviation and interaction with intermetallic particles.

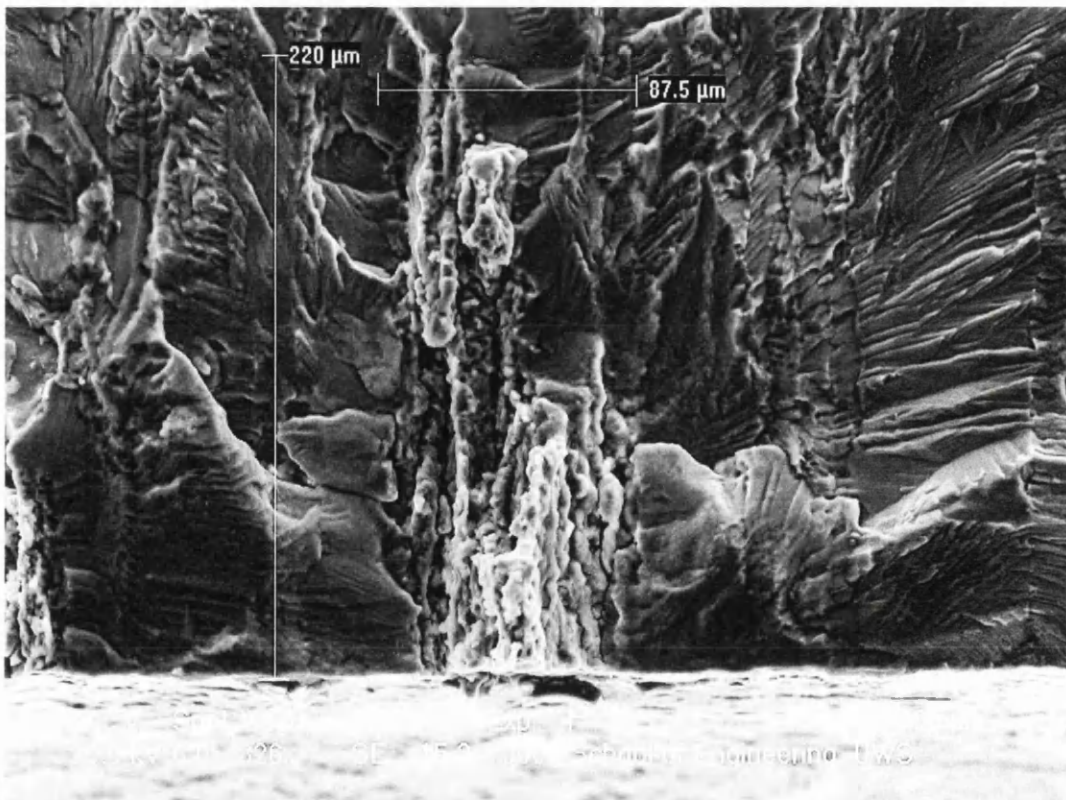
**Figure 6.11** Typical examples of the size and morphology of corrosion pitting on AA7010-T7651 after one corroding week.

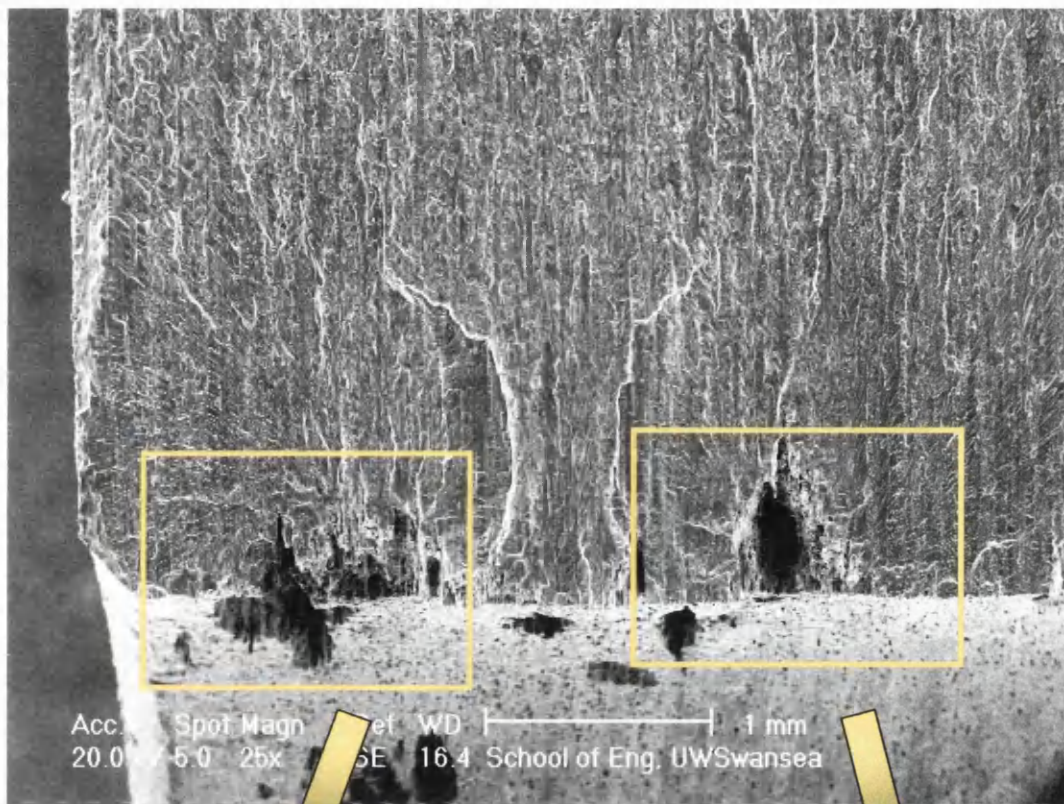
**Figure 6.12** Corrosion pitting observed on 52 week specimens.
